TECHNICAL ASSISTANCE TEAM FOR EMERGENCY RESPONSE REMOVAL AND PREVENTION
EPA CONTRACT 68-01-7367

MEMORANDUM

SUBJECT: Synkote Paints
Site Assessment

DATE: April 7, 1989

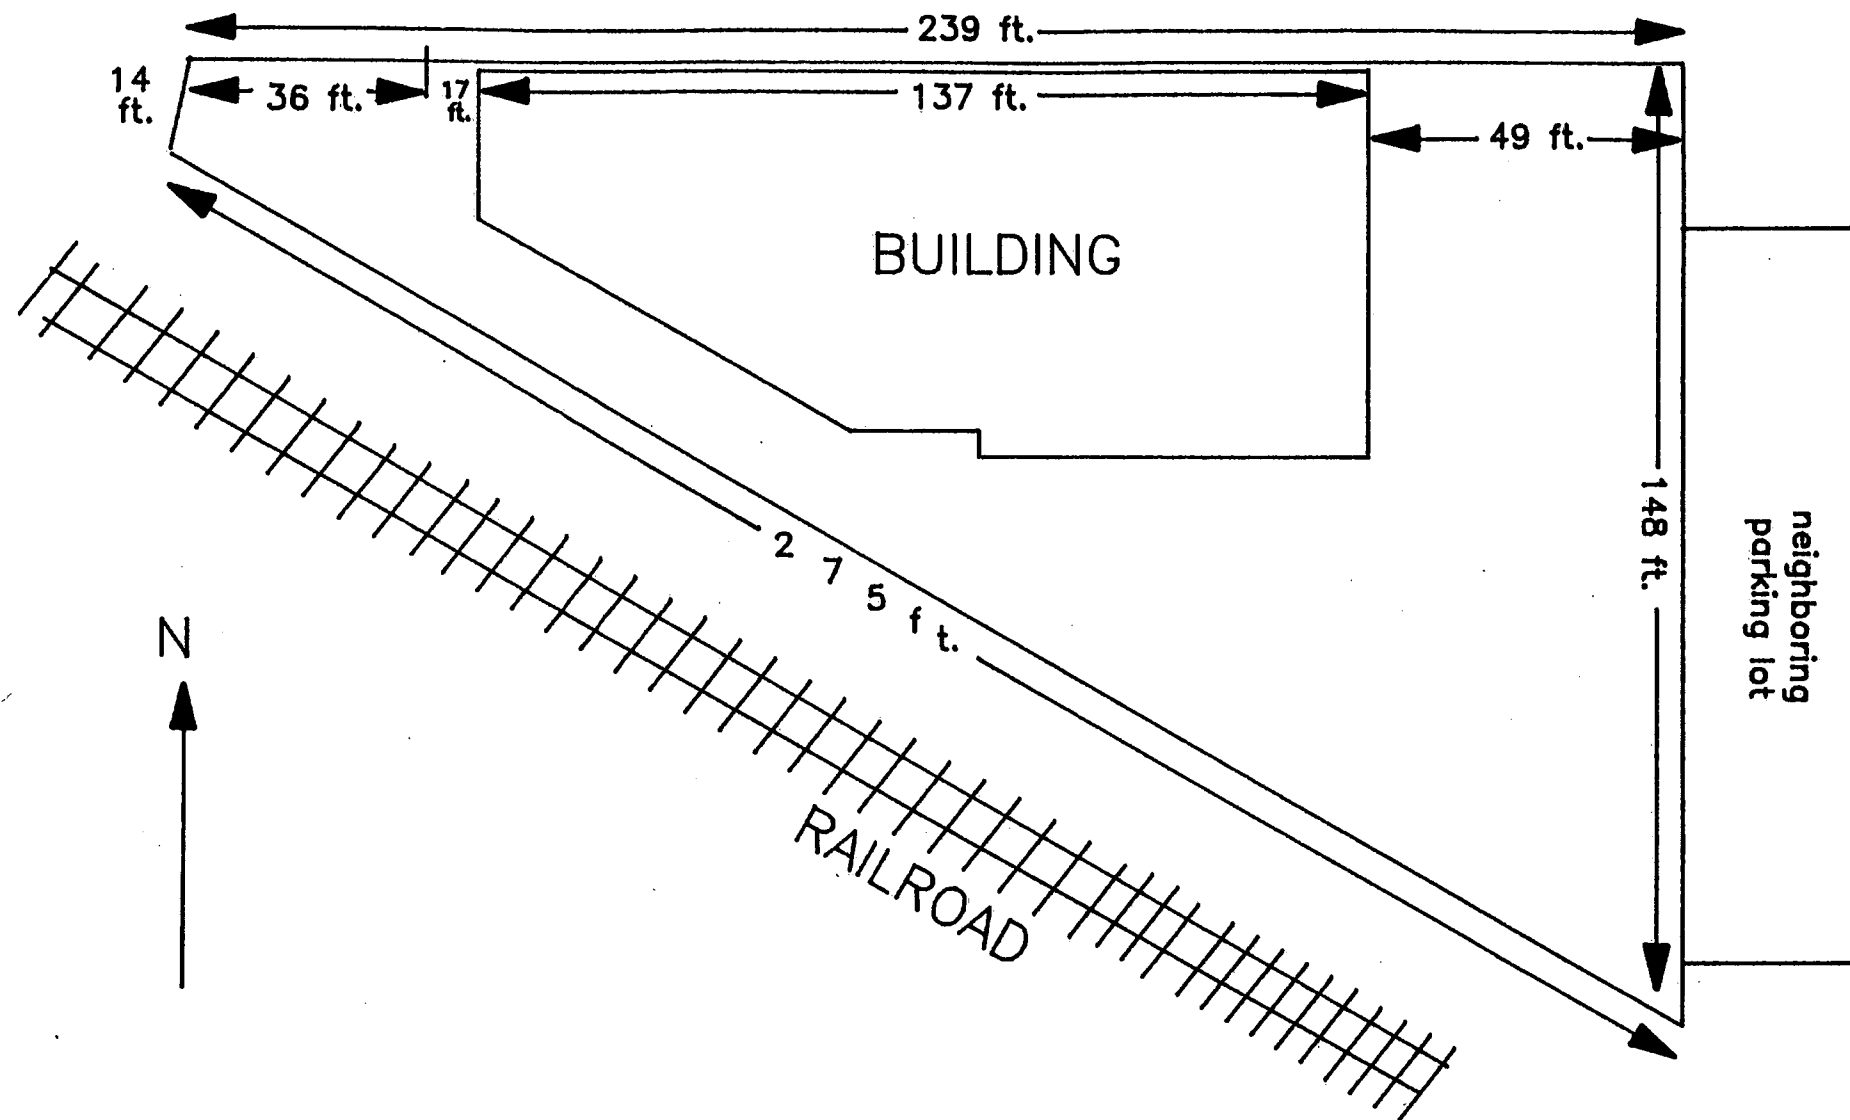
Figure 2
Site Map

The Synkote Paint site is located in Elmwood Park, New Jersey in Bergen County. The site consists of a one story, 10,000 square foot building on a half acre lot. The site is bordered by Van Riper Avenue to the north, railroad tracks to the south and west and a business parking lot to the east. See figures 1 and 2.

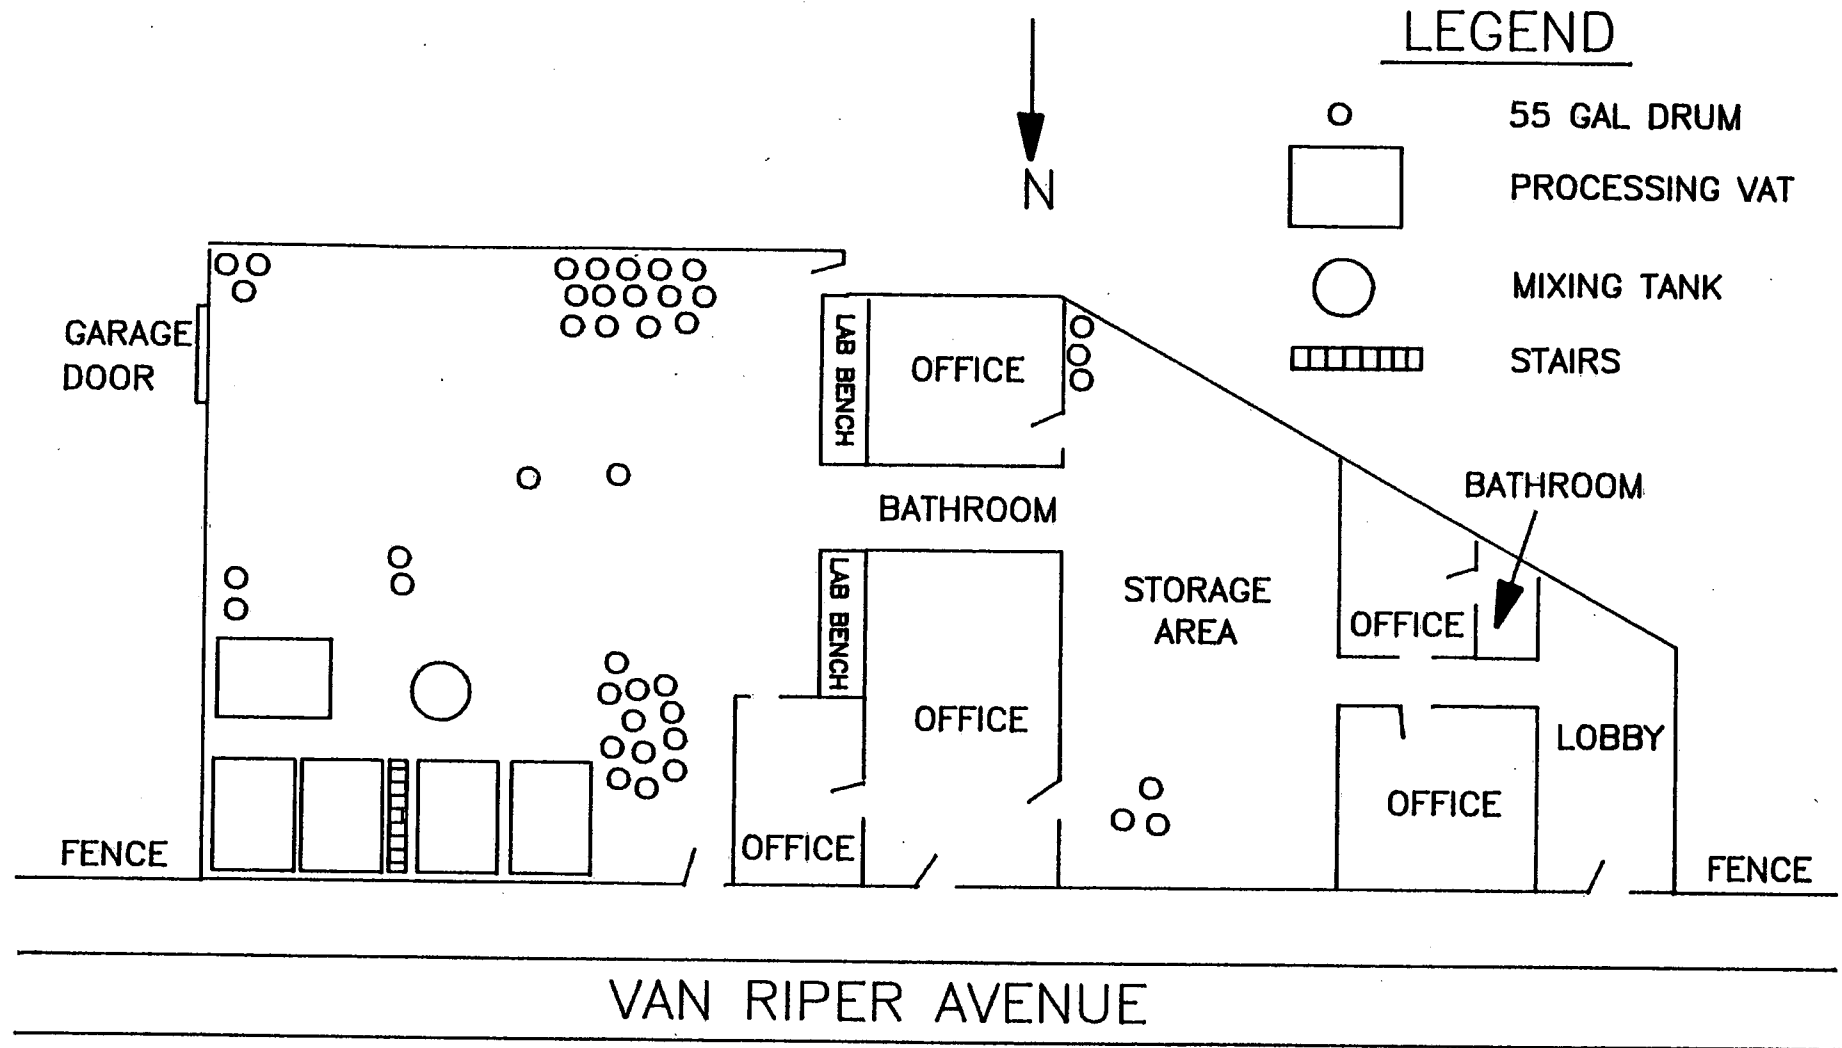
Figure 3
Building Interior

The processing room contains the majority of waste inside the building. Located in this room are two groups of 55 gallon drums, two laboratory benches, and 5 vats. The group located on the north side of the room contains 12 drums. Fourteen drums are contained in the group located on the south side of the room. Both groups of drums gave elevated OVA and HNU readings in the range of 0-8 units above background when the OVA or HNU probe was placed adjacent to the rim of the drums. Appendix 1 contains the result of air monitoring performed at the site. The laboratory bench contains a number of chemicals, most of which are related to the processing of paint solvents and pigments into paint.

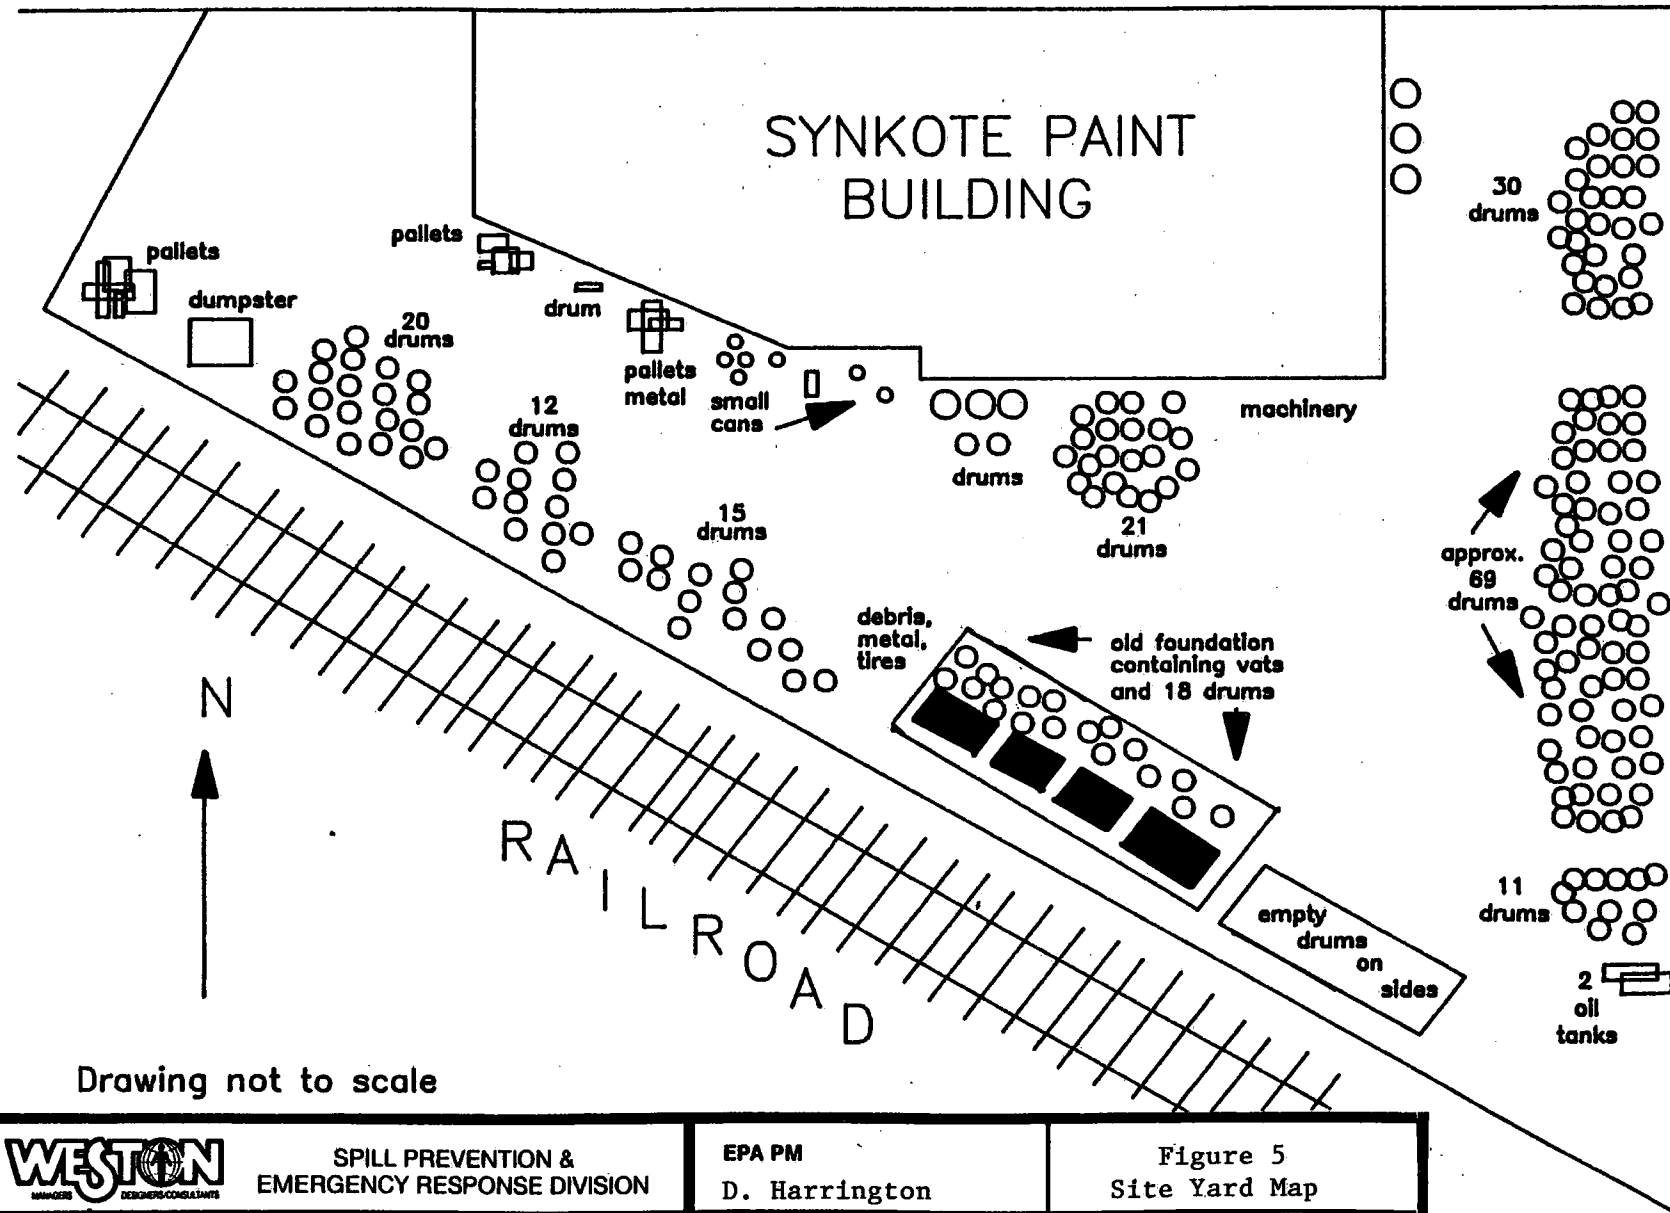
Figure 5
Site Yard Map

The rear yard of the site is enclosed by a 6-foot chain link fence in fair condition. Approximately 210 weathered and corroded drums were found in the yard as designated in figure 5. TAT's inspection disclosed several drums with partly lifted lids or corrosion holes in the tops and/or sides of the drums. These drums, along with two closed drums, gave elevated OVA readings in the 0 - 3 units range. One drum on the east side of the lot containing a white substance on its top gave elevated OVA readings in the 18 - 28 units range. Two of the drums had labels on their sides indicated that the drums were explosion hazards when empty. One bulging drum was found on the east side of the site, near the parking lot for the adjacent facility.

In summary the site contains a number of chemical hazards which should be immediately addressed. These include the laboratory bench which contains a number of incompatible substances in close proximity to each other, a bulging drum which could detonate at any time and several drums which are presently releasing their contents to the environment in the rear of the site. It is recommended that measures to secure or remove these hazards be implemented.
